A public meeting point: “Sebil” of Nuruosmaniye

Nilüfer SAĞLAR ONAY, Ayşe Hilal UĞURLU
Istanbul Technical University Faculty of Architecture, Istanbul TURKEY

The restoration process of the Sebil of Nuruosmaniye

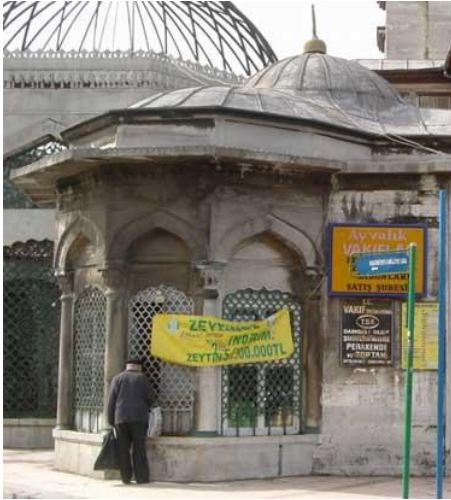
commercial functions such as stores, cafes etc. which contradict with their original architectural identity. (Figure 1-2)

Figure 1. The Sebil of Gülnus Emetullah Valide Sultan (Saglar Onay archive)

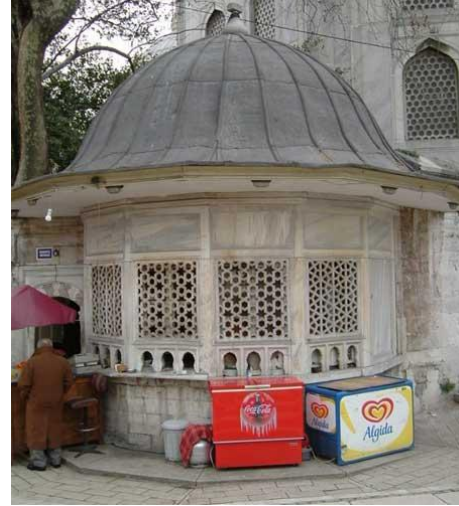
Figure 2. The Sebil of Ibrahim Han (Saglar Onay archive)

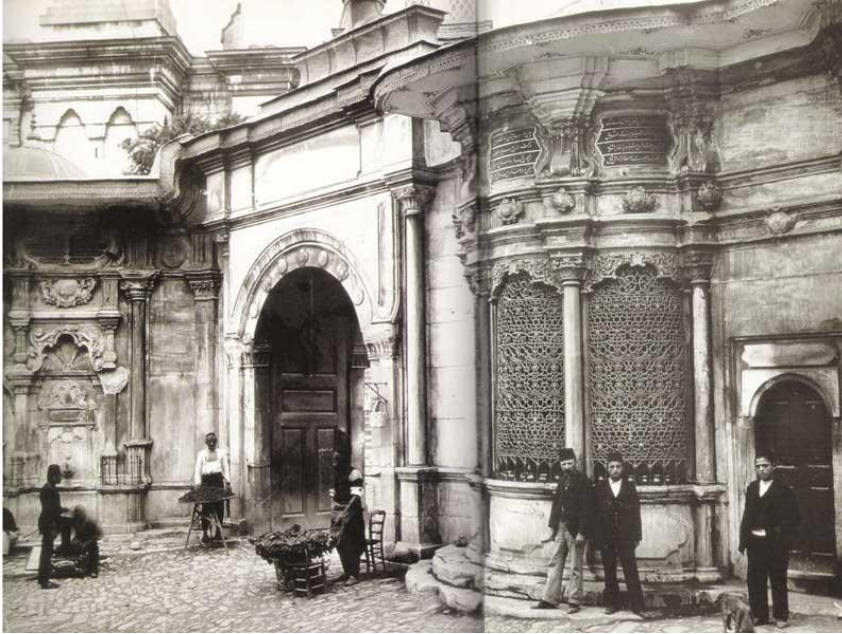
Figure 7. The situation of the Sebil of Nuruosmaniye in the beginning of the 20th Century (Evren, 1999)

The presence of a wooden eave was determined in a photograph which was taken in the beginning of the 20th century. Although no trace of the eave was detected on the existing structure the restoration drawings were created by

the help of the photograph and structural analyses on other Baroque Sebils in Istanbul which have wooden eaves. After the tambour was reinforced by mortar and adhesives, the eave was hanged on it by the help of fittings and anchorages.

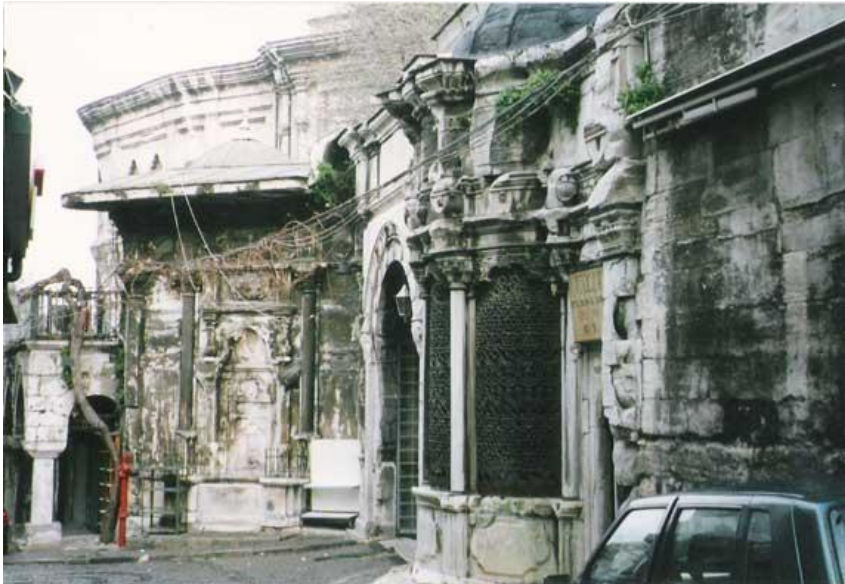
Figure 8. The situation of the Sebil of Nuruosmaniye before the restoration (Saglar Onay archive)

The Sebil of Nuruosmaniye which belongs to the “General Directorate for Foundations”, has been rented for 49 years by a tradesman selling traditional Turkish carpets. The sebil, which is situated in between the main entrance of Grand Bazaar and the courtyard of the Baroque Nuruosmaniye Mosque, was under the threat of falling into ruins until 2003 although it is undoubtedly at a spot that all tourists pass by. To prevent the Sebil from collapse and to renovate it as a resting place for tourists, the project started in 2000. The Restoration Project of the Sebil which was considered in the First Prevention Group was approved in May 2001 and it was decided by the “Cultural and Natural Heritage Conservation Board” in December 2002 to proceed the restoration practice under the control of the Istanbul Regional Directorate for Foundations. The restoration which started in April 2003 was completed in September 2003.

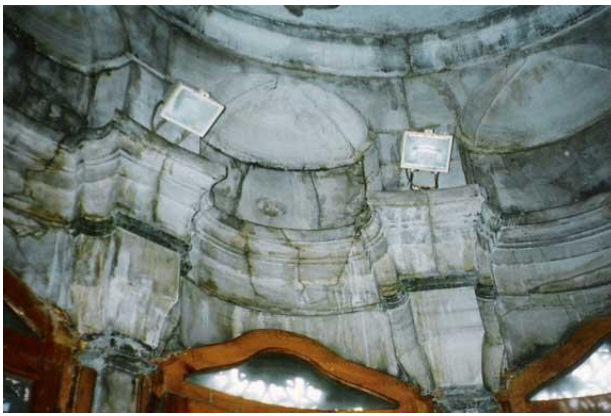
Figure 11. The Interior of The Sebil of Nuruosmaniye - The situation before restoration (Saglar Onay archive)

After the structural elements and the outer shell of the building were restored, the interior which was comparatively in better condition was handled. The electrical installation which was scattered all around the interior was renewed and hidden. (Figure 10-11-12) The tin gratings originally called "sebeke" were cleaned with special metal brushes. The additional metals used to close the original bottom tiny holes, from which water was delivered, were removed.

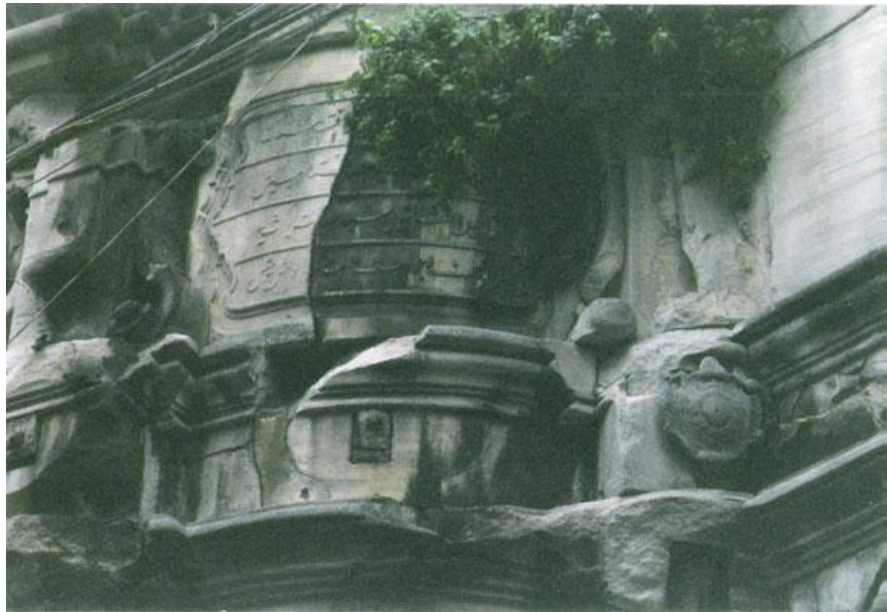
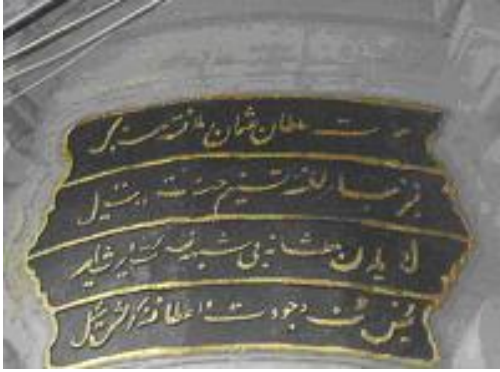
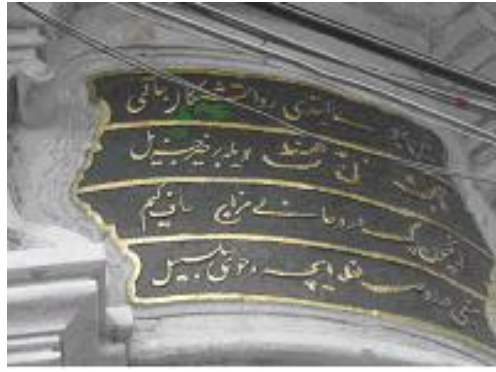
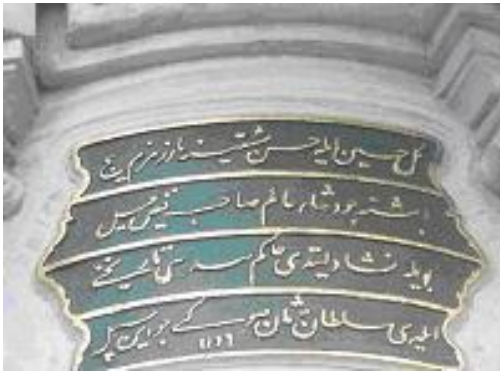
Table 1. The Inscriptive cartouches of the Sebil of Nuruosmaniye – The situation after the Restoration (Neftçi, 1996)

Finally the planar ornamentations originally called “tezyinat” on the inner surface of the dome were completed similar to the remaining ornamental details. The ornamentations under the outer eave were realized according to a 100 year old photograph. The colors of the inner and outer ornamentations were chosen to resemble other religious buildings and palaces in Istanbul; reddish outside, blue inside. The last ornamentation step was to cover the religious inscriptive cartouches with gold leaves. (Figure 13-14-15-16-17)

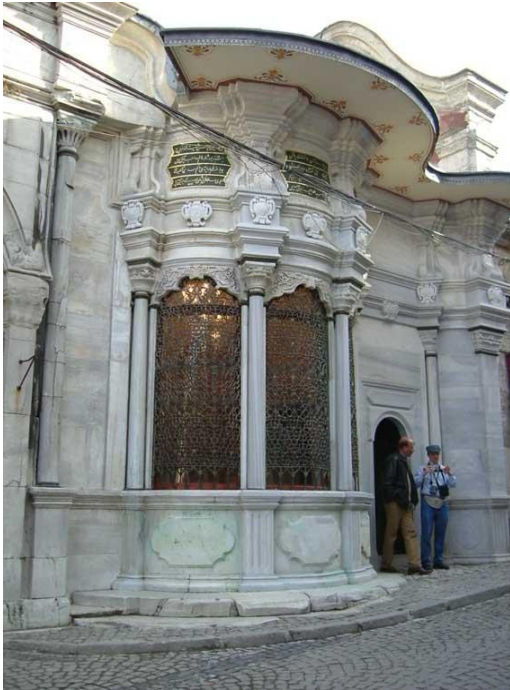
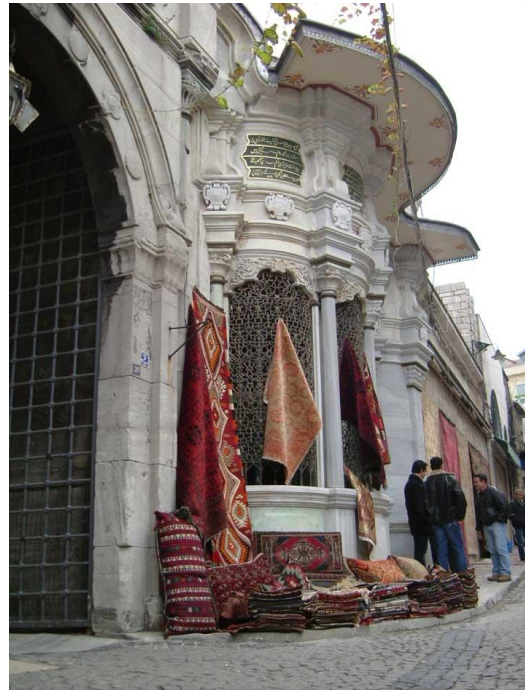
Figure 18. The Sebil of Nuruosmaniye after Restoration, 2003 (Saglar Onay archive)

The Sebil of Nuruosmaniye is now being used as an exhibition and disposal space for traditional Turkish Carpets by the tradesman who had rented the Sebil for 49 years and paid for the restoration. (Figure 18-19) Although the present use of the Sebil seems to offer a public space conception, the general spatial organization is completely guided by commercial concern. In fact, the original typology of Sebil embodies a spatial conception that is formed by the principle of public benefaction.
